Third-Party Technology Verification of the Hydropath Technology at the J. B. Messerly Water Pollution Control Plant, Augusta, Georgia.

PREPARED FOR: Tal Journo/*HydroFLOW* USA LLC (*HydroFLOW* USA)
PREPARED BY: Samuel Jeyanayagam, PhD, PE, WEF Fellow/Jacobs (Jacobs)
DATE: November 5, 2018

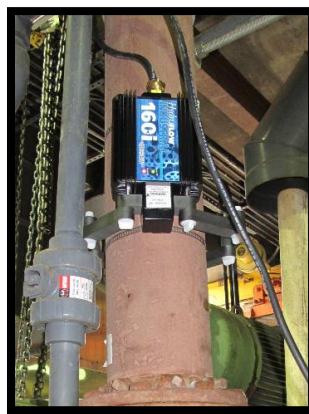
The *HydroFLOW* I Range is powered by the patented Hydropath technology. When properly installed on a pipe (see Figure 1), it induces a 150 kilohertz, oscillating sine wave, alternating current (AC) signal. The electric induction is performed by a special transducer connected to a ring of ferrites. The pipe and the flowing fluid act as a conduit, which allows the signal to propagate. The induced AC signal is believed to cause the mineral ions that make up struvite (magnesium, ammonium, and phosphate) to form loosely held together clusters. When certain conditions are created (e.g., pressure change, temperature change, and turbulence) the clusters precipitate out of solution and form stable crystals of struvite that remain in suspension. The crystals are not able to adhere to surfaces as hard scale and are carried away with the flow. Because hard scale no longer accumulates, the shear forces created by the flowing liquid erode and soften existing scale deposits over time. It is important to note that constant liquid flow is required to remove hard scale deposits from a system.

Figure 1: Installed *HydroFLOW* unit (Model 160i) at a wastewater treatment plant

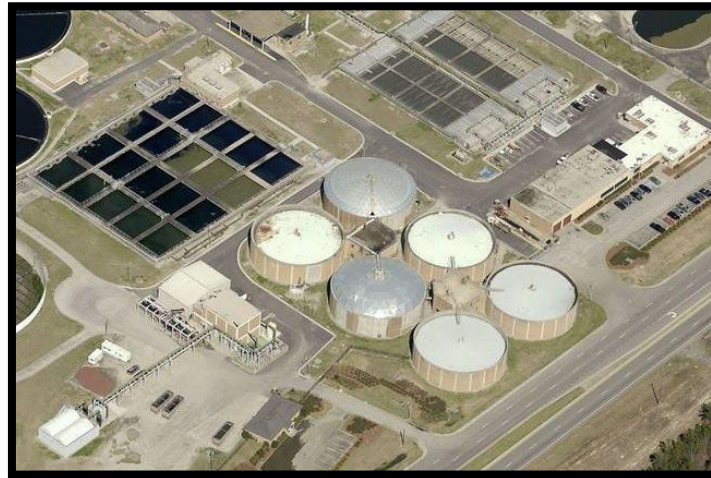
Figure 2: The J. B. Messerly Water Pollution Control Plant

The WPCP (see Figure 2) is one of four wastewater treatment plants that serve the City of Augusta's service population. It is managed, operated, and maintained by the City's Water and Sewer Department. The WPCP, designed for 46 mgd, currently treats an average flow of 20 mgd.

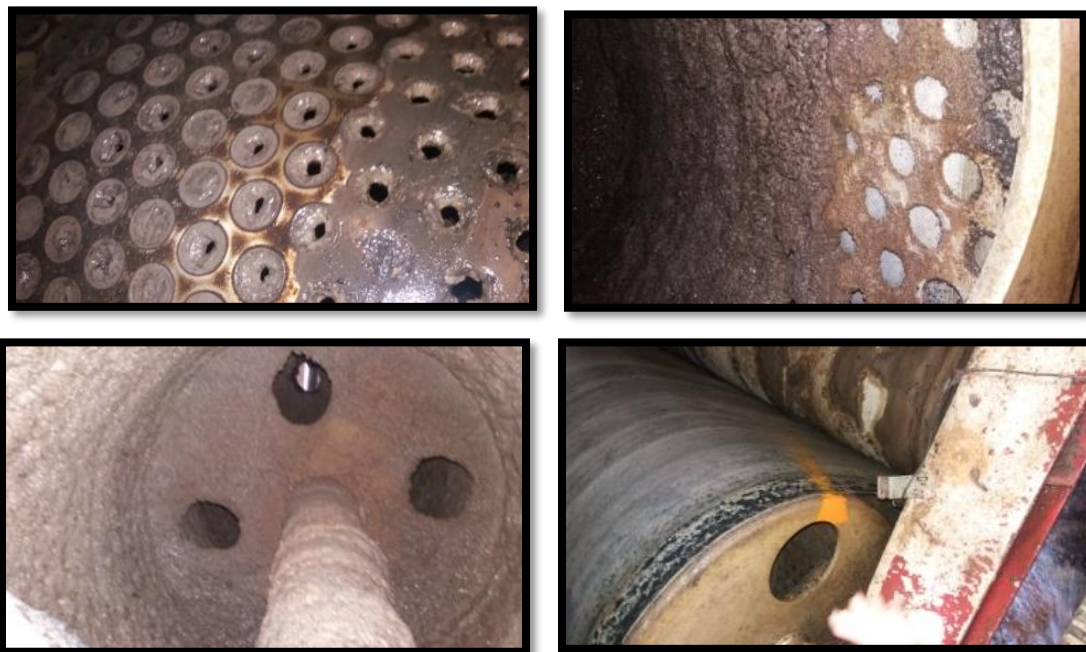
Before energizing the *HydroFLOW* unit, several pictures were taken to establish baseline condition. As shown in the Figure 4 below, heavy struvite encrustation was evident on the drum surface. Other parts of the BFP also showed struvite scale accumulation.

Figure 4: Baseline condition on 7th September 2017 before *HydroFLOW* was activated

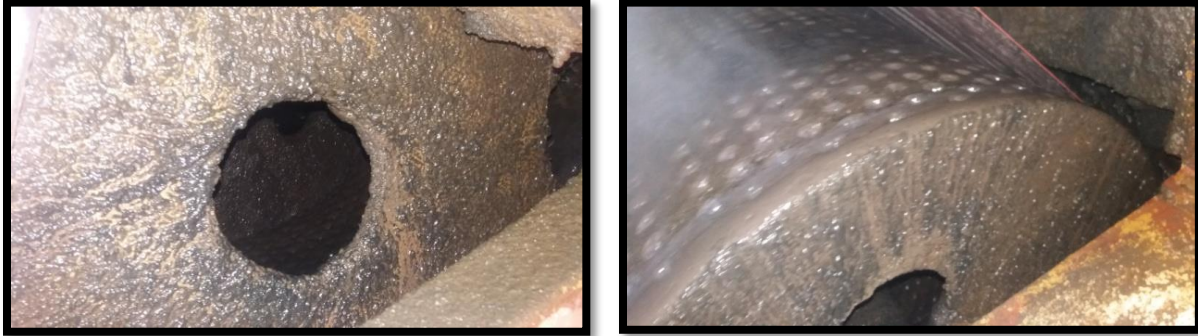
Several pictures, taken on 1st March 2018, were made available for review. These pictures (Figure 5), taken at the end of the 6-month test period, appeared to show softened and reduced scaling.

Figure 5: Final condition on 1st March 2018

One *HydroFLOW* I Range was installed on the sludge feed line to one of the BFPs to evaluate its effectiveness in controlling scaling. The available photographic information and data was insufficient and did not allow a direct comparison between baseline, intermediate, and final observations of scale accumulation. Consequently, it is not possible to solely rely on the provided photographs to make definitive conclusions.

However, following the installation of *HydroFLOW* and discontinuation of anti-scalant, existing scale became soft and was easily removed by spraying with high pressure water. The observations of the plant operating staff at the WPCP are consistent with findings at other facilities where *HydroFLOW* has been tested.
