HydroFLOW Cooling Tower Inspection Report

Nellis Air Force Base

Updated on June 26, 2019

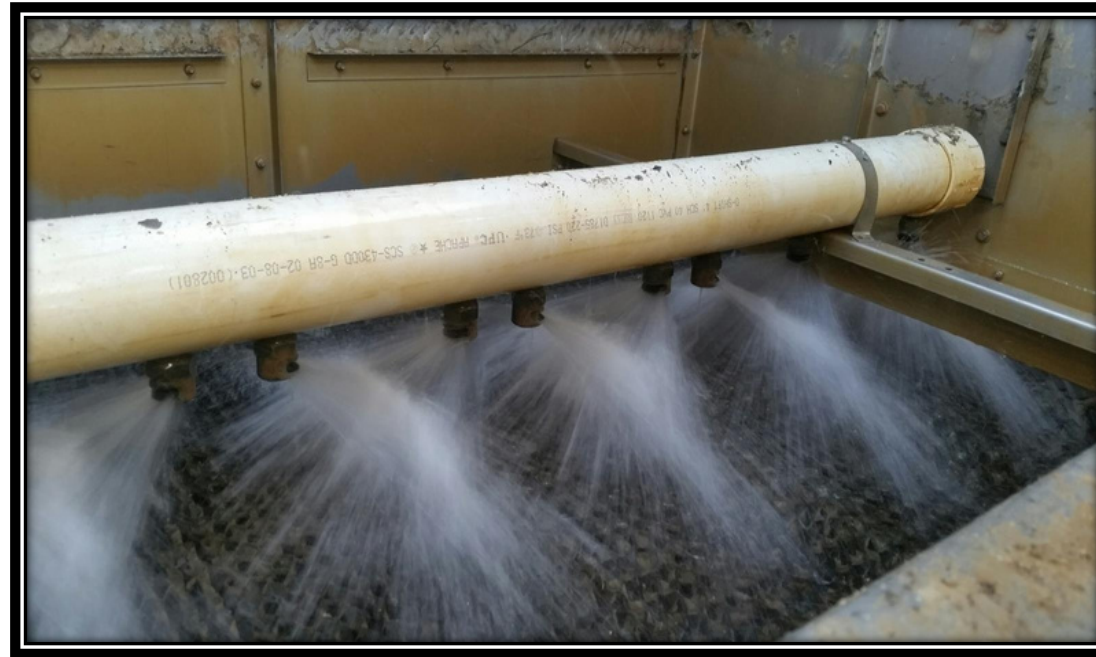
Due to equipment malfunction, the cooling tower's conductivity meter read 14,000 μS , which was 6 times too high. Airman Payne repaired the damaged system and reset the controller back to the normal operational parameters of 2,300 μS . No significant hard scale or bio buildup was observed on the nozzles or infrastructure.

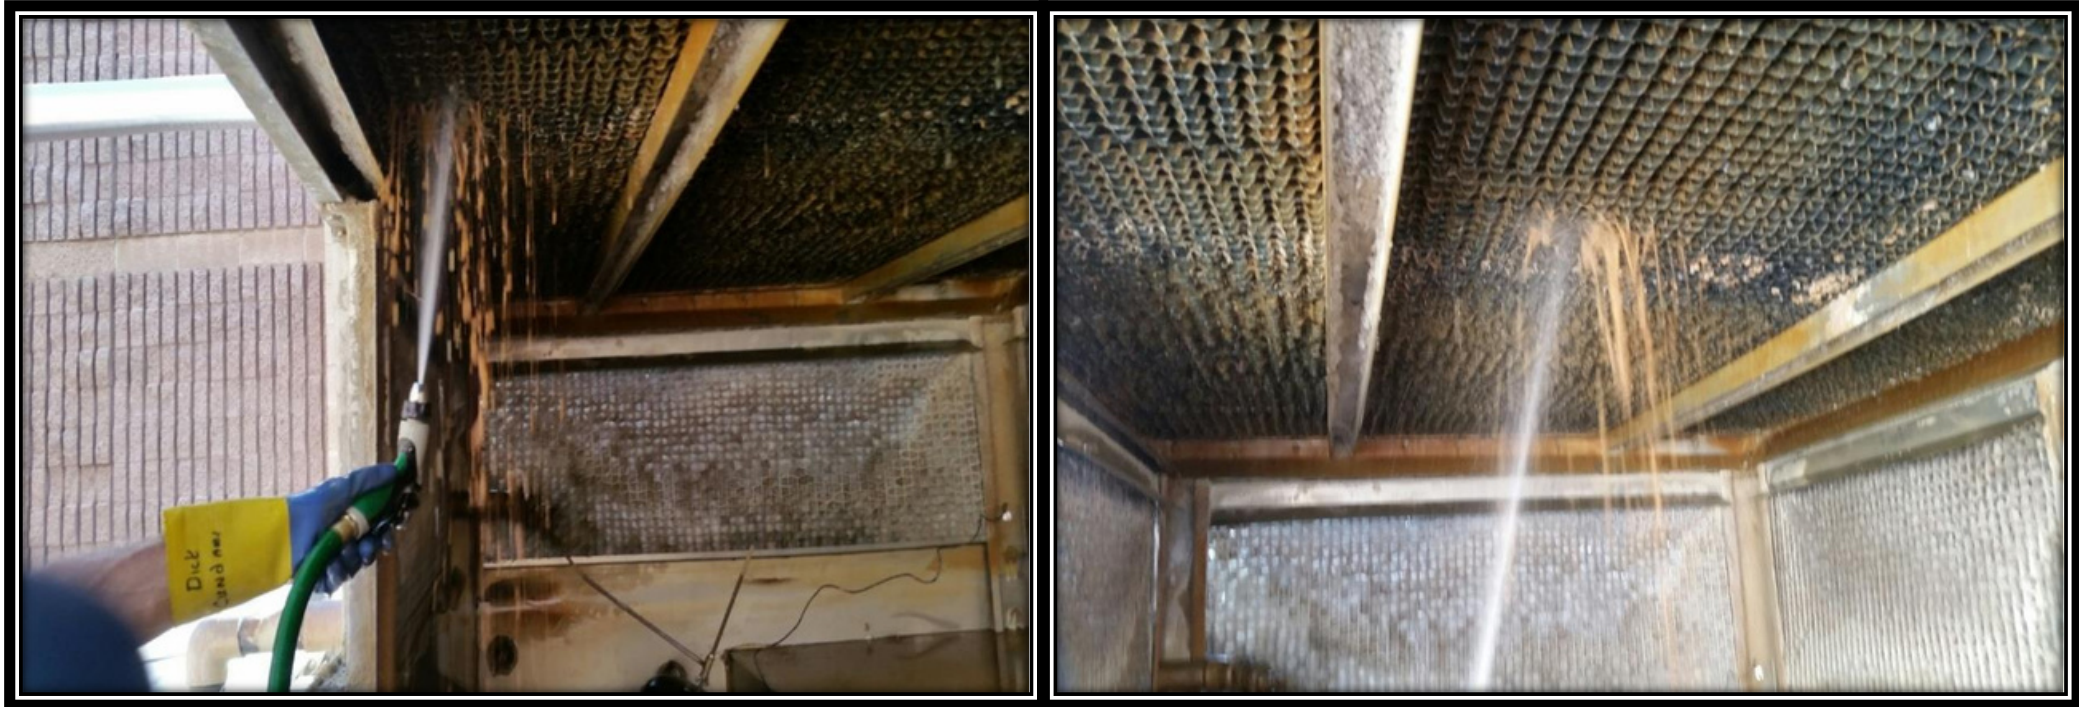
Instead of the hard scale that typically accumulates inside the cooling tower, loose brown mud-like material was found. A garden hose was used to easily remove the mud-like substance from the fill material and the drift eliminators.

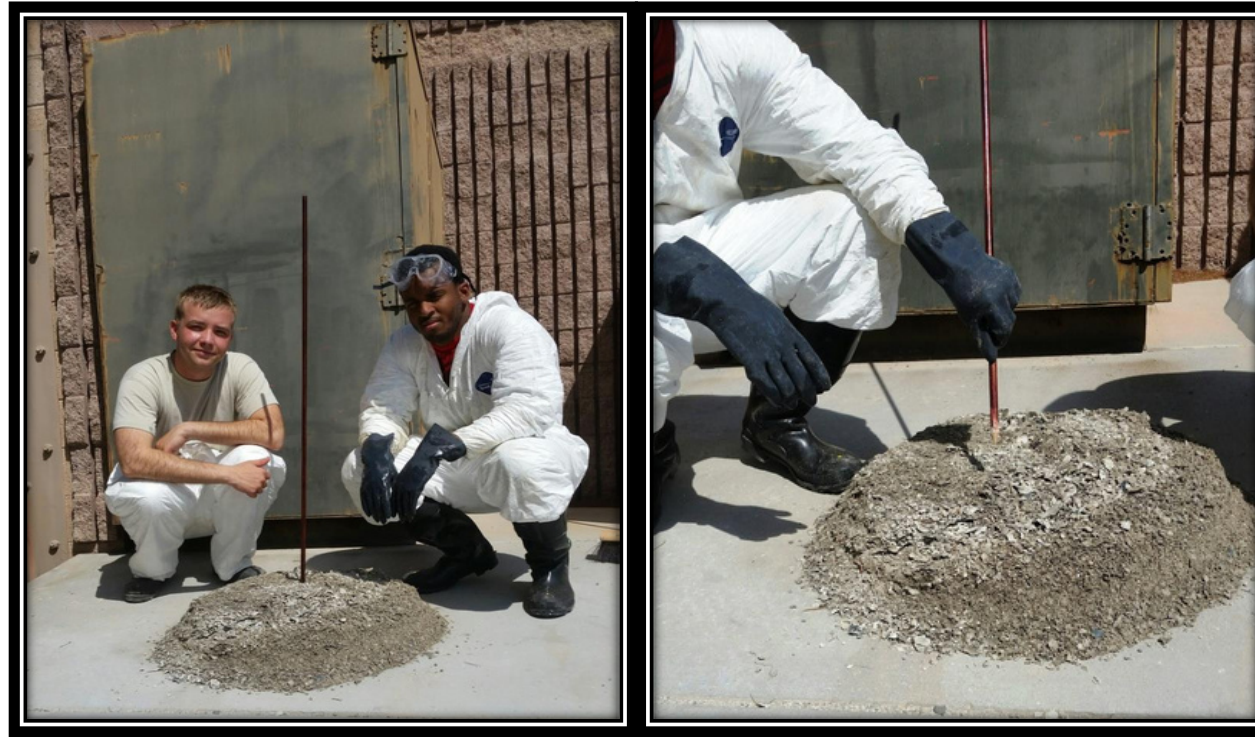
Senior Airman Buckanan and Airman Payne pictured next to the scale that was removed from the drift eliminators. The pile measured 30” in circumference at the base and 24” at the top, the depth was approximately 6”.

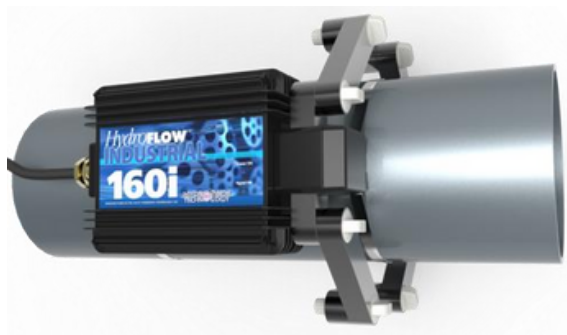
A *HydroFLOW* model 160i was installed on cooling tower 11. During the month of March 2019, a *HydroFLOW* representative inspected the cooling tower and 160i-both were in excellent operating condition.
